The Marine Laboratory  
Institute Of Marine Science  
UNIVERSITY OF MIAMI

EVALUATION AND APPLICATION OF A SPECIAL WEATHER  
RADAR RECEIVER SYSTEM  
March, 1962

Final Report

INSTITUTE OF MARINE SCIENCE  
Radar Meteorological Section  
University of Miami  
Coral Gables, Florida

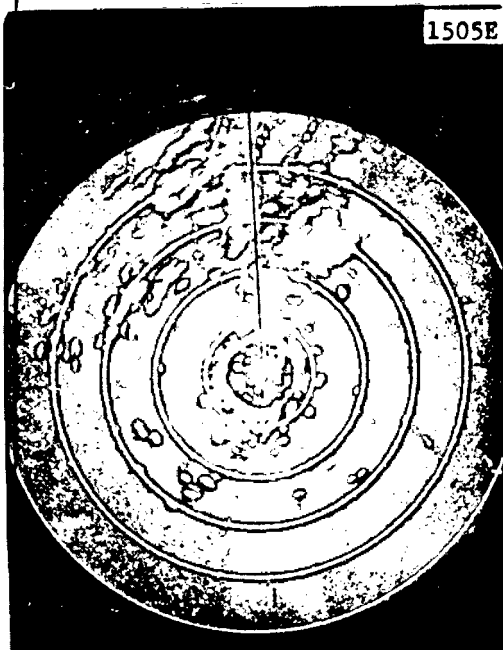
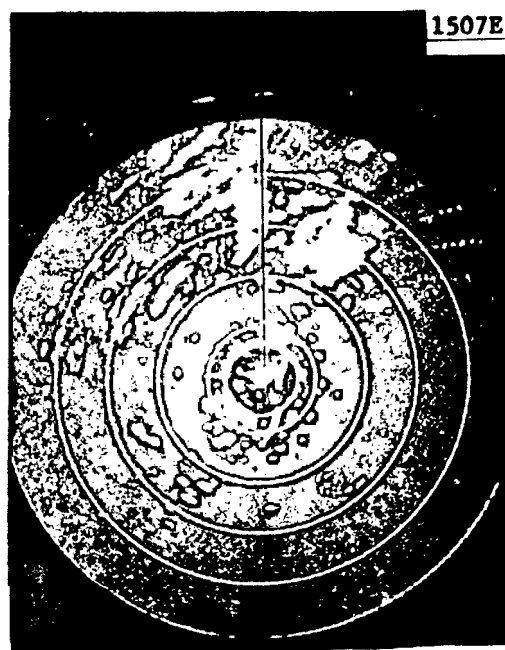
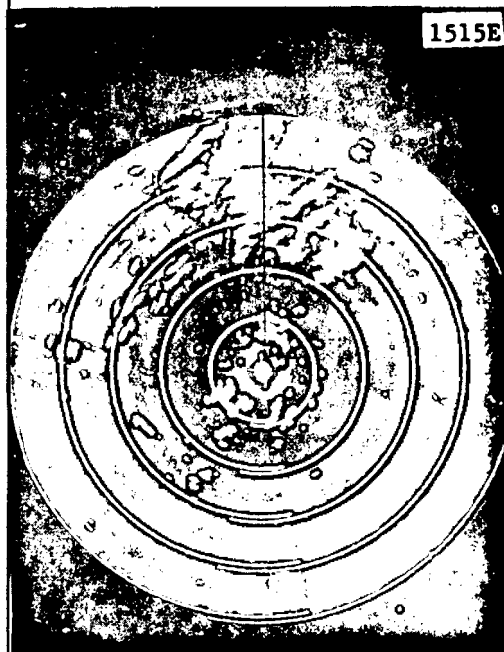
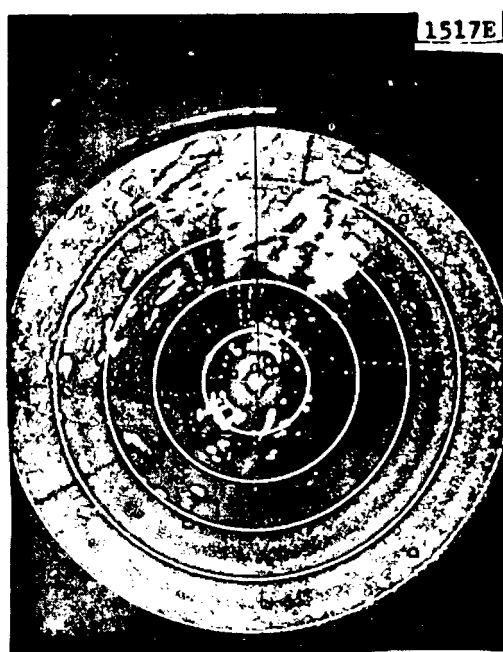
LOG RECEIVER  
NO RANGE CORRECTION

LINEAR RECEIVER  
NO RANGE CORRECTION

12 N. MI. CENTER STC ON ALL PHOTOGRAPHS

LOG RECEIVER  
RANGE CORRECTED

LINEAR RECEIVER  
RANGE CORRECTED

FIG. 8.2- COMPARISONS OF LOG AND LINEAR, RANGE CORRECTED AND NON-RANGE CORRECTED, PRESENTATIONS USING NEW COLLINS RECEIVER ON SP-1M RADAR, UNIV. OF MIAMI; 18 OCTOBER 1961, 5  $\mu$  PULSE 750 KW PEAK POWER, 20 N. MI. RANGE CIRCLES

Figures 8.2 and 8.3 illustrate the capabilities of this receiver system for detecting and displaying precipitation echoes. Both of these illustrations show PPI photographs made with the linear and logarithmic receiver with and without the use of the Range Attenuation Corrector. Interference from the Federal Aviation Agency's ASR-1 radar at Miami Airport is visible in all of the photographs, particularly in the northern quadrants.

The mode of operation for most reliable quantitative information is with the log receiver and range corrector on. In these illustrations, the 5-mile range increments of the range attenuation corrector were adjusted so that there was a 20 decibel reduction in sensitivity of the receiver system at 10 miles range with the sensitivity increasing as a function of  $1/R^2$  to maximum sensitivity at 100 nautical miles and beyond.

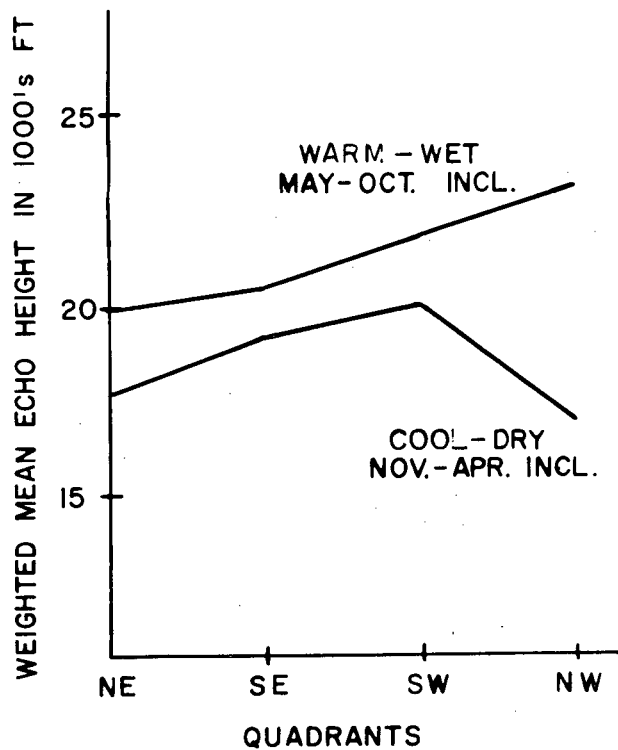
FIG. 9.3-WEIGHTED MEAN ECHO HEIGHTS BY QUADRANTS AND SEASONS

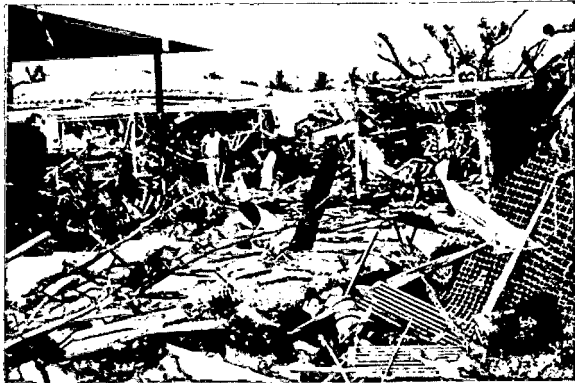
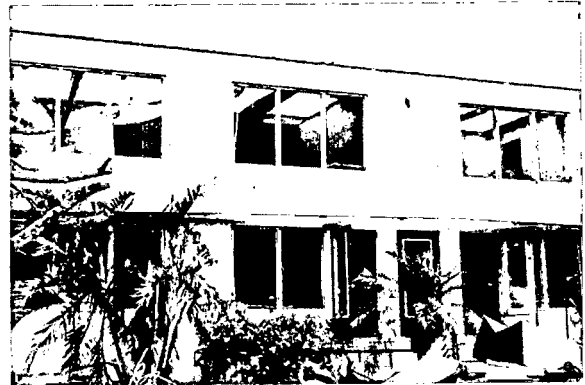
FIG. 10.1 - TORNADO DAMAGE IN N.E. MIAMI, 17 JUNE 1959. NUMBERS REFER TO LOCATIONS ON MAP OF TORNADO TRACK.

The severity of this tornado is clearly evident from the extent of structural damage as shown in Figure 10.1. The numbered photographs in Figure 10.1 correspond to the locations shown on the map in Figure 10.2.
